# Inspection Report

## Sample Report

**Quest Property Inspections Inc**

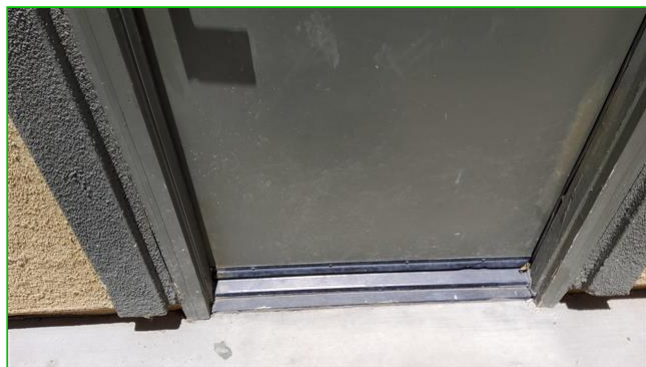
1.3 Item 1

Door Trim shows signs of water infiltration. Evidence of dryrot ( Wood Rot ) or Fungus damage caused by dryrot or wood destroying pest and organisms. Recommended to have a qualified licensed pest control company to evaluate

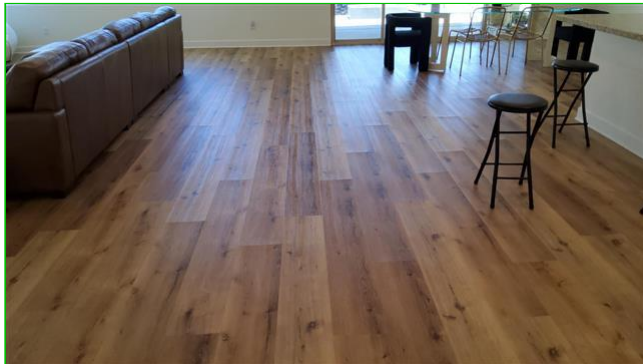
7.8 Item 1

Note: Laminate flooring throughout house buckling / warping. Buckling or warping is almost always as a result of moisture and/or water damage. Laminate flooring is affected by water in a number of ways. High moisture content in the air can sometimes lead to buckling or warping. Excessive water on the surface of the floor can also lead to buckling or warping. For this reason, it is important never to wet mop a laminate floor. Recommended to have a licensed flooring contractor evaluate and make recommendations for repairs.

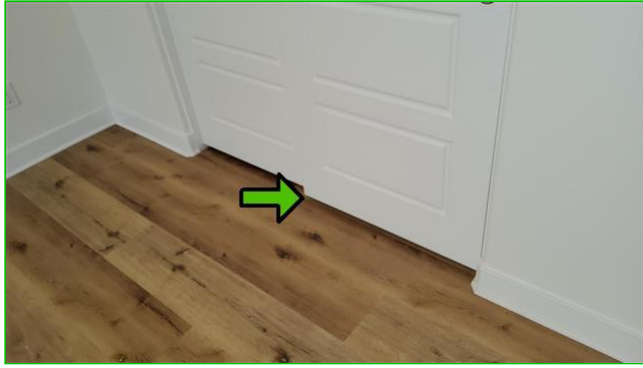
17.8 Item 1

Wardrobe bottom door glide was missing. This allows the wardrobe doors to swing freely. Swinging doors may fall from the header rail and cause injury to the occupant. Safety concern.

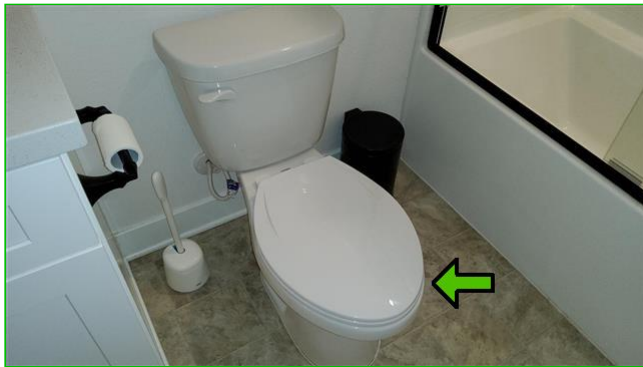
19.10 Item 1

The toilet is loose at floor. Repairs may involve re-setting the toilet on a new wax seal. I recommend a qualified licensed plumber repair or correct as needed.

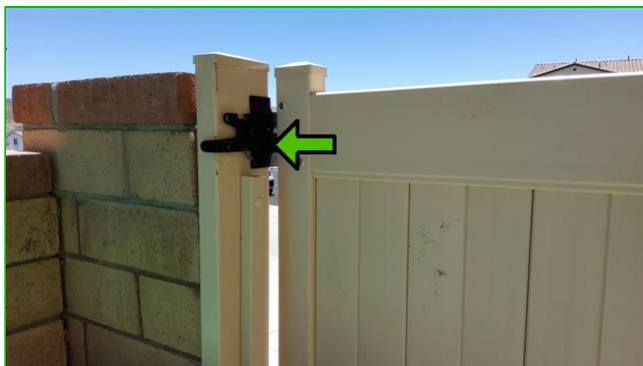
22.20 Item 1

Gate(s) not self closing and **latching**. Needs to be serviced: Location

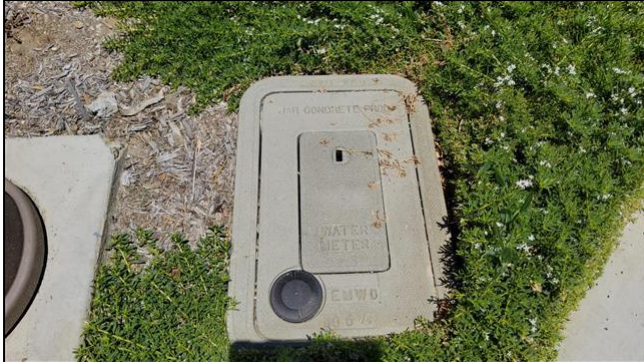
1.1 Item 1

(1) The water source is the public utility company. Water meter shut off located at street. Water meter condition at time of inspection. Normal wear for age. House main shut off see photo.

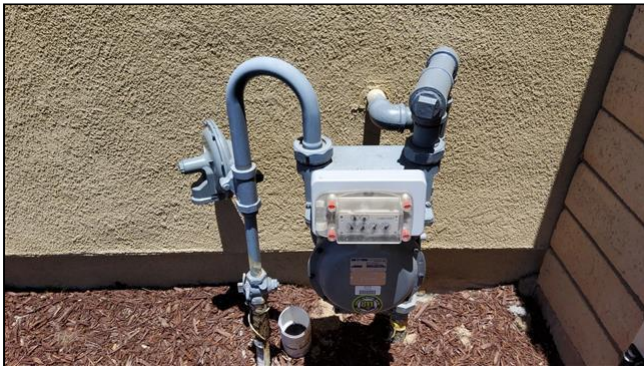
1.1 Item 3

(2) The fuel source is natural gas and is supplied by the public utility company. Location of gas meter : Side of house.

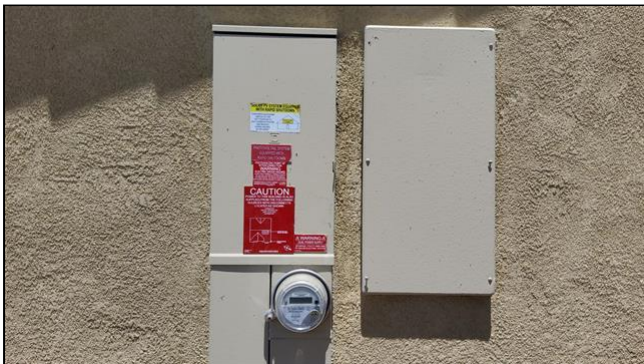
1.1 Item 4

(3) The source for Electricity is the public utility company. Location of Electrical meter : Side of house. Condition of Meter at time of inspection-Normal wear for age.

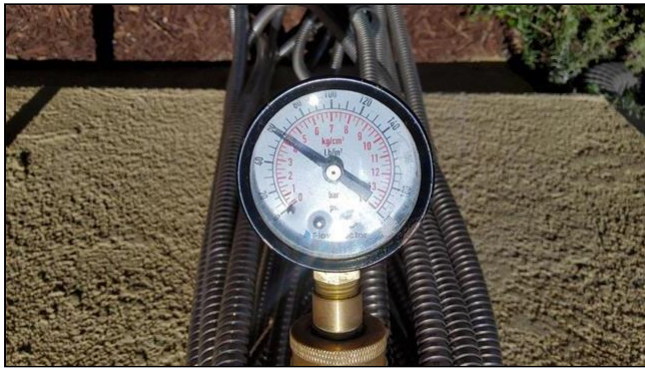
1.2 Item 1

Recommended water pressure is between 55 to 80 PSI approximate psi at time of inspection 60 PSI

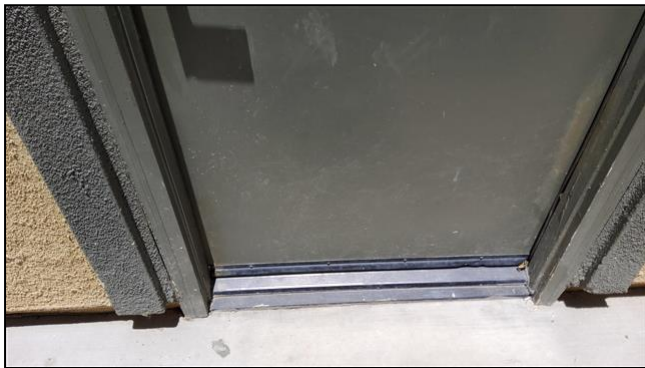
1.3 Item 1

Door Trim shows signs of water infiltration. Evidence of dryrot ( Wood Rot ) or Fungus damage caused by dryrot or wood destroying pest and organisms. Recommended to have a qualified licensed pest control company to evaluate

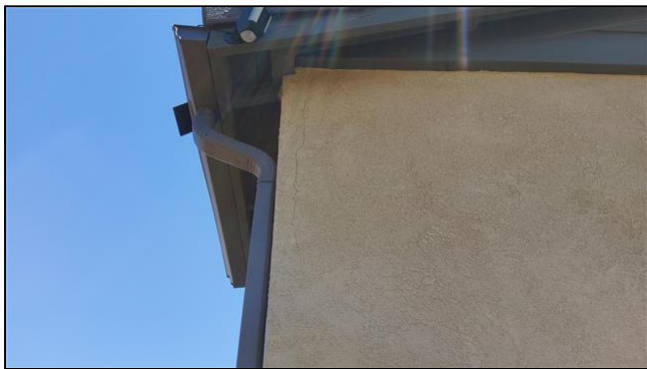
1.8 Item 1

Stucco shows signs of typical weathering do to age. Recommended sealing any penetrations / gaps to prevent moisture and or pest to enter. Stucco finishes require seasonal maintenance, consult an qualified licensed contractor for maintenance tips and preventive maintenance.

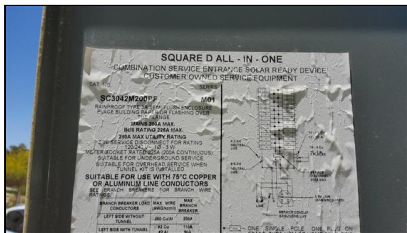
2.1 Item 1

The main electrical panel was manufactured SquareD. The panel is rated for 120/240 Volts and is in good condition.

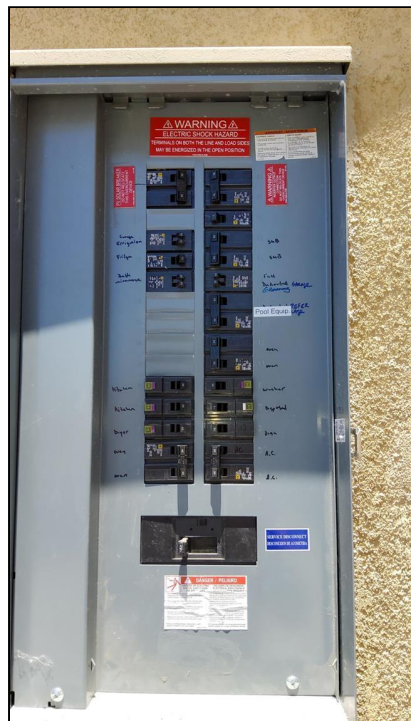
2.4 Item 1

Number of breakers in off position: 0 Number of unused breakers: 5 Labels are present on panel cover the inspector does not check for accuracy of labels. Normal wear for age at time of inspection.

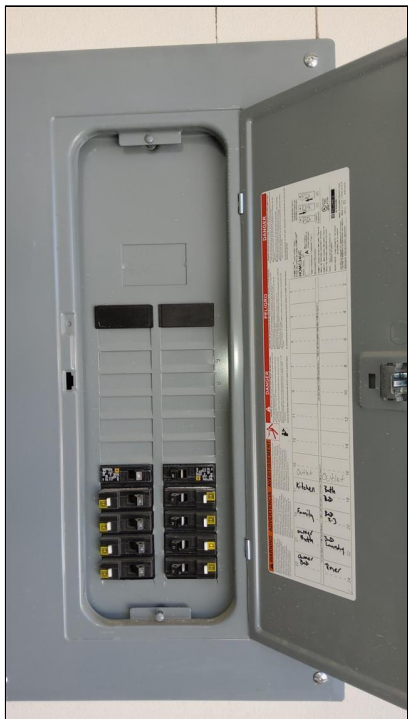
2.12 Item 1

Normal wear for age at time of inspection. No viable defects.

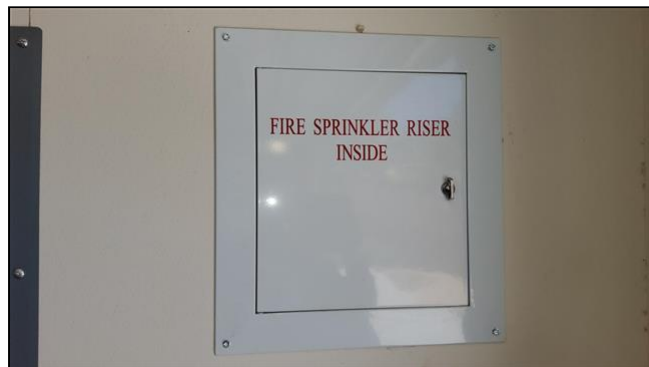
3.7 Item 1

**FIRE SPRINKLERS FIRE SPRINKLER CONDITIONS:** Your home is equipped with a fire suppression system. Also referred to as fire sprinklers. These systems are excluded from the home inspection process and are excluded from the home inspection industry standards of which your home was inspected. If the home inspector makes comments regarding the fire sprinkler system it is done as a courtesy only. Any comments should be followed up with a licensed professional in your area certified to inspect and or repair fire sprinkler systems.

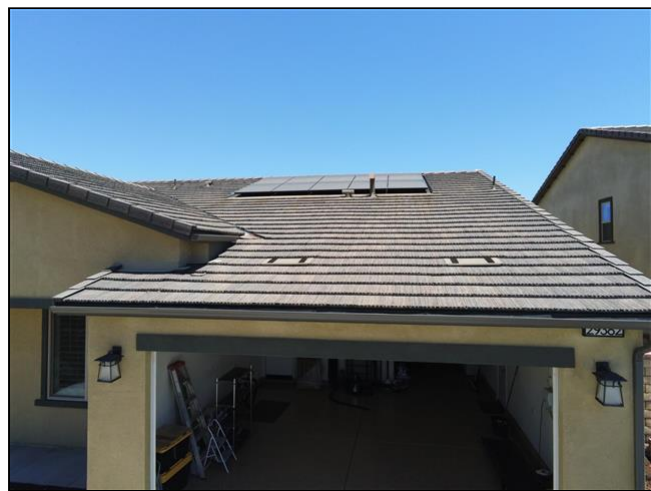
4.0 Item 1

Recommendation-Seasonal maintenance every 3-5 years to include mastic maintenance around all flashing(s) and penetration(s) areas to extend the life of the current materials.

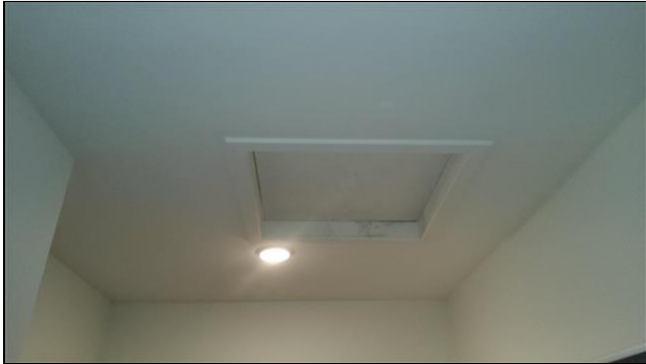
4.4 Item 1

The attic access is located in Master bedroom closet ceiling. Attic was inspected from entering attic. Inspected all areas that were accessible. Some areas not inspected due access limitations. Normal wear at access door-no visible defects. Roof Structure conventional framing is present. Normal wear for age of structure. No visible defects at time of inspection.

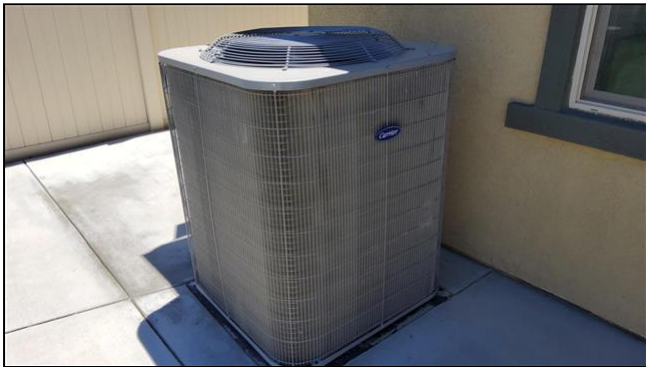
6.2 Item 1

A/C condenser responded normally to testing. Air-conditioning output temperatures were good on day of inspection.

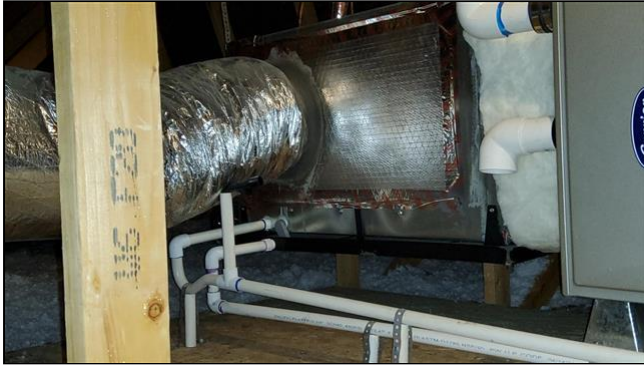
6.6 Item 1

Evaporator: Visible areas of the coil box have normal wear at time of inspection. No major visible defects present at time of inspection.

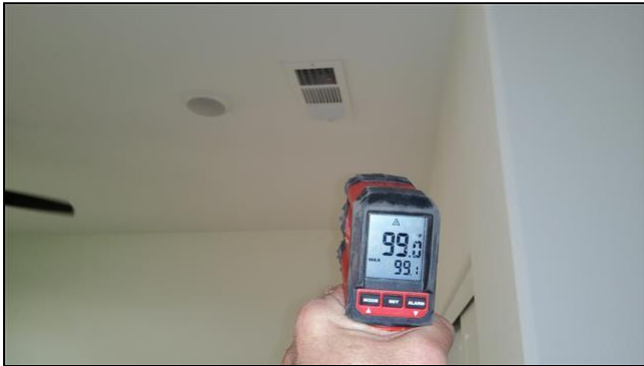
6.7 Item 1

(1) Output temperatures of the heating system were satisfactory on the day of inspection. Outside Temp at time of inspection.

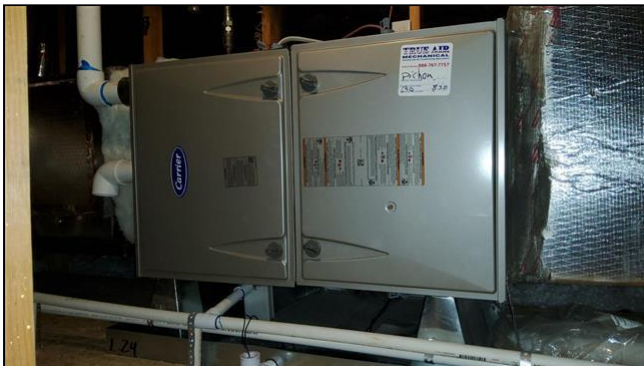
6.7 Item 2

(2) Heater/Furnace operated at time of inspection. Visible areas of unit have normal wear for age at time of inspection. No major visible defects. Recommend seasonal service and maintenance to extend life of the unit(s).

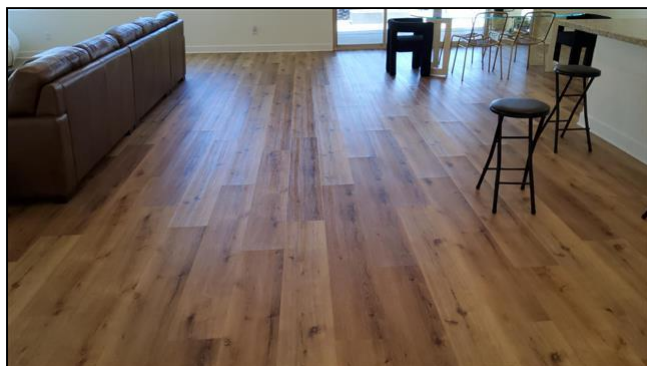
7.8 Item 1

**Note:** Laminate flooring throughout house buckling / warping. Buckling or warping is almost always as a result of moisture and/or water damage. Laminate flooring is affected by water in a number of ways. High moisture content in the air can sometimes lead to buckling or warping. Excessive water on the surface of the floor can also lead to buckling or warping. For this reason, it is important never to wet mop a laminate floor. Recommended to have a licensed flooring contractor evaluate and make recommendations for repairs.

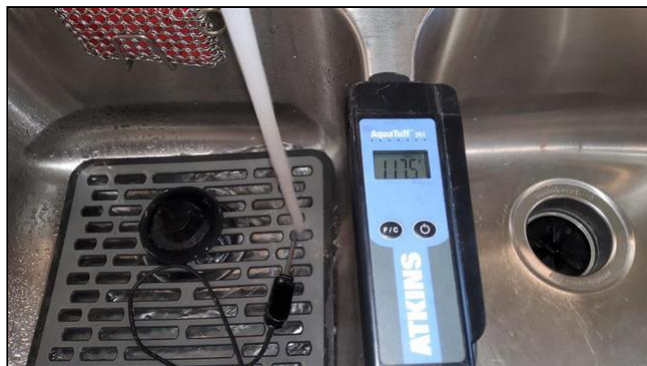
11.8 Item 1

Fixture(s) operated at time of inspection. Existing fixtures are worn-typical for age of materials. Drain stopper(s) operated at time of inspection. Hot water- Temps at 117.5 degrees, recommended adjusting the temperature at the water heater.

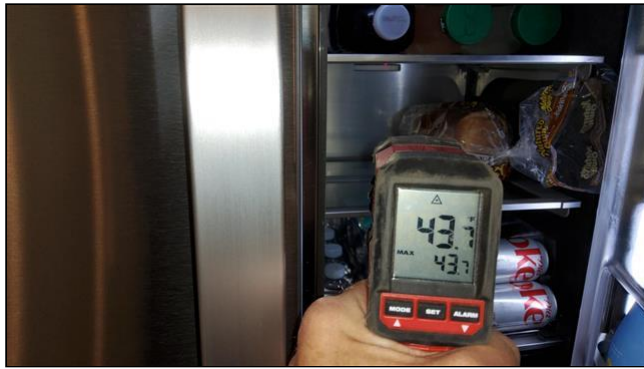
11.16 Item 1

The refrigerator was in satisfactory condition.

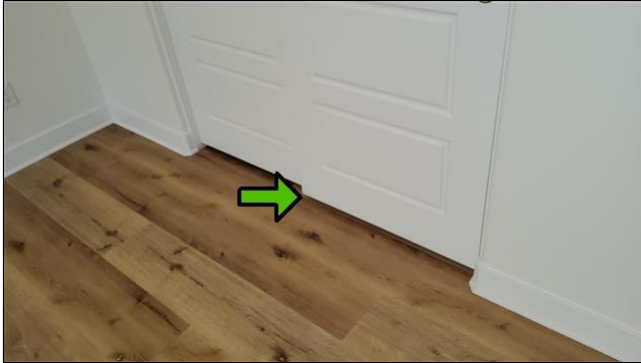
17.8 Item 1

Wardrobe bottom door glide was missing. This allows the wardrobe doors to swing freely. Swinging doors may fall from the header rail and cause injury to the occupant. Safety concern.

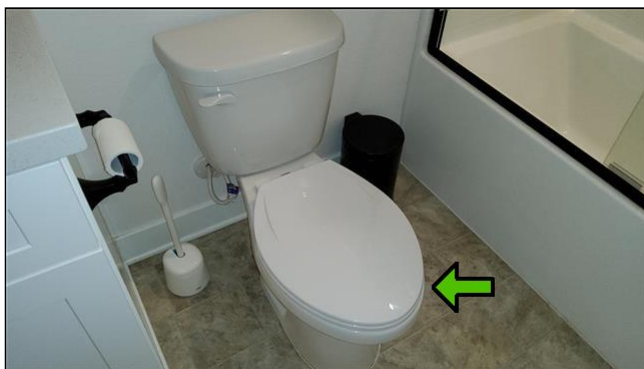
19.10 Item 1

The toilet is loose at floor. Repairs may involve re-setting the toilet on a new wax seal. I recommend a qualified licensed plumber repair or correct as needed.

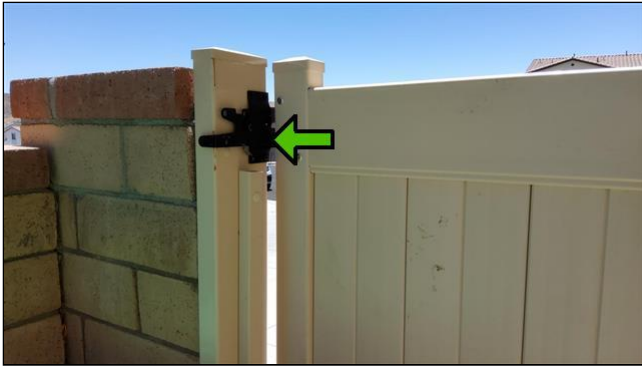
22.20 Item 1

**Gate(s) not self closing and latching. Needs to be serviced: Location**
